NATIONAL PROGRAM FOR INSPECTION OF NON-FEDERAL DAMS
WINDSOR UPPER DAM (VT.) (U) CORPS OF ENGINEERS WALTHAM
MA NEW ENGLAND DIV SEP 78

WINDSOR UPPER DAM VT 00013

SECTION 7 - ASSESSMENT, RECOMMENDATIONS AND REMEDIAL MEASURES

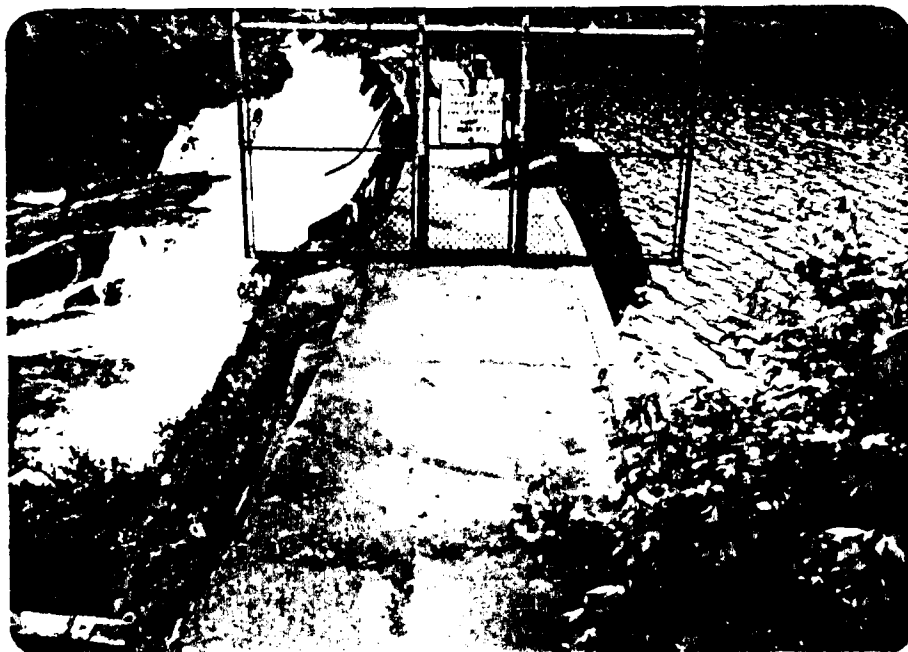
FIG. 7

Operators for penstock and sluice gates.
(Penstock operator in foreground).

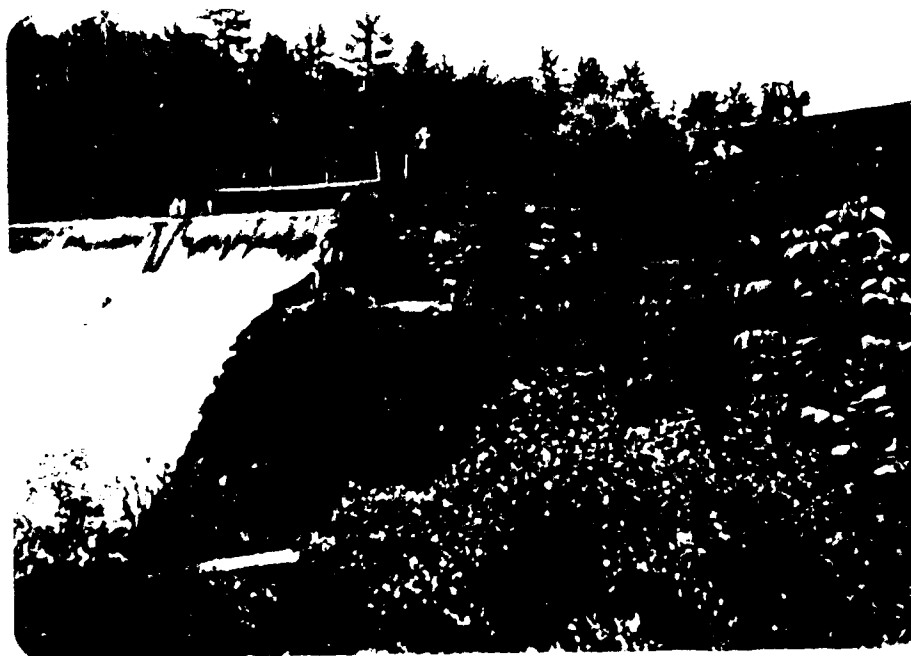
FIG. 8

In addition, the downstream face of the dam is overgrown with small bushes and trees. This condition could eventually cause leakage problems, if allowed to continue. The downstream face of the dam must be annually cleared of all brush.

Main spillway and auxiliary spillways as viewed from
downstream. (Note vegetation on downstream face).
